# DREDGED MATERIAL RESEARCH PROGRAM

MISCELLANEOUS PAPER D-77-2

## FIELD STUDY TO DETERMINE THE FEASIBILITY OF ELECTRO-OSMOTIC DEWATERING OF DREDGED MATERIAL

November 1977

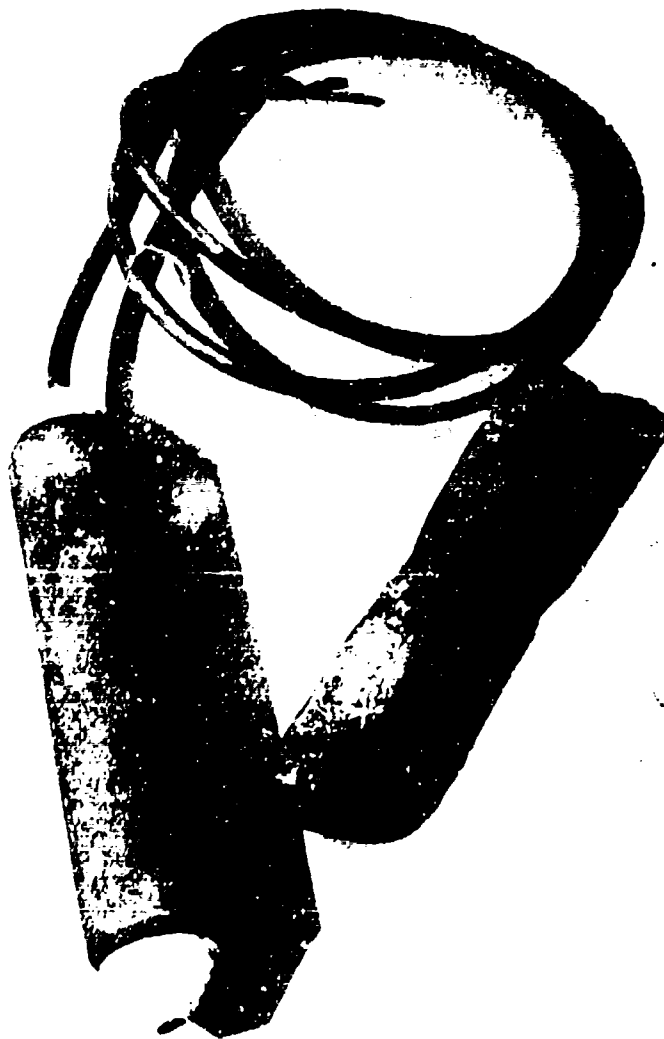
Figure 10. New 10.0-kg Duriron electrode and one that has lost one half its weight after use for 25 days at a voltage gradient of 0.01 V/mm

74. In Sections 3 and 4, the 10.9-kg Duriron electrodes failed by loss of electrical connection in about 53 days. Since it would have taken 3 weeks to obtain new ones from the manufacturer, a hardened aluminum bronze bar, approximately 50.8 mm diam, 1 m long, was used for the electrical connection. These bars lasted only 16 days, but were locally available, thereby allowing the test to continue. Figures 21 and 22 show deterioration of the Duriron and hardened aluminum bronze metal use as connectors in the coke-breeze sections.

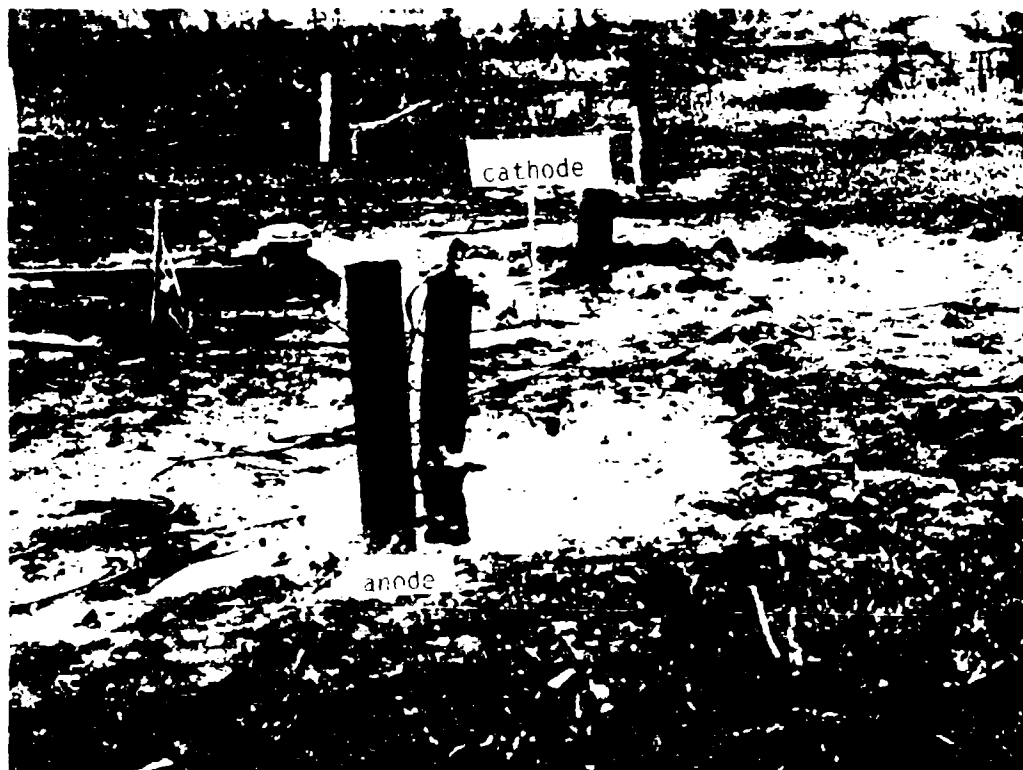
Figure 13. Standing water at anode, Section 2

63. During January 1977, it rained for a total of 14 days in Mobile; accumulated rainfall was 140.7 mm. In February, 47.24 mm fell in a period of 6 days, and, during the first 2 weeks of March, 73.31 mm fell in a total of 7 days. This rain caused the anodes and cathodes to often be submerged in water; this is shown in Figures 13 and 14.

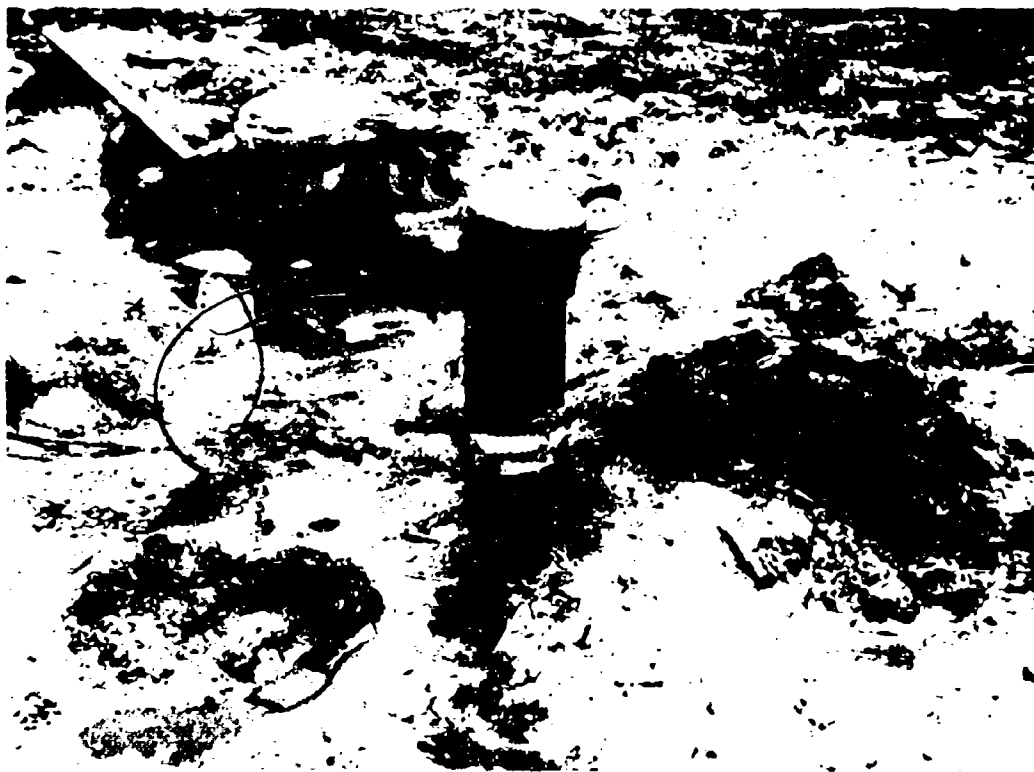
Figure 14. Standing water at cathode, Section 1

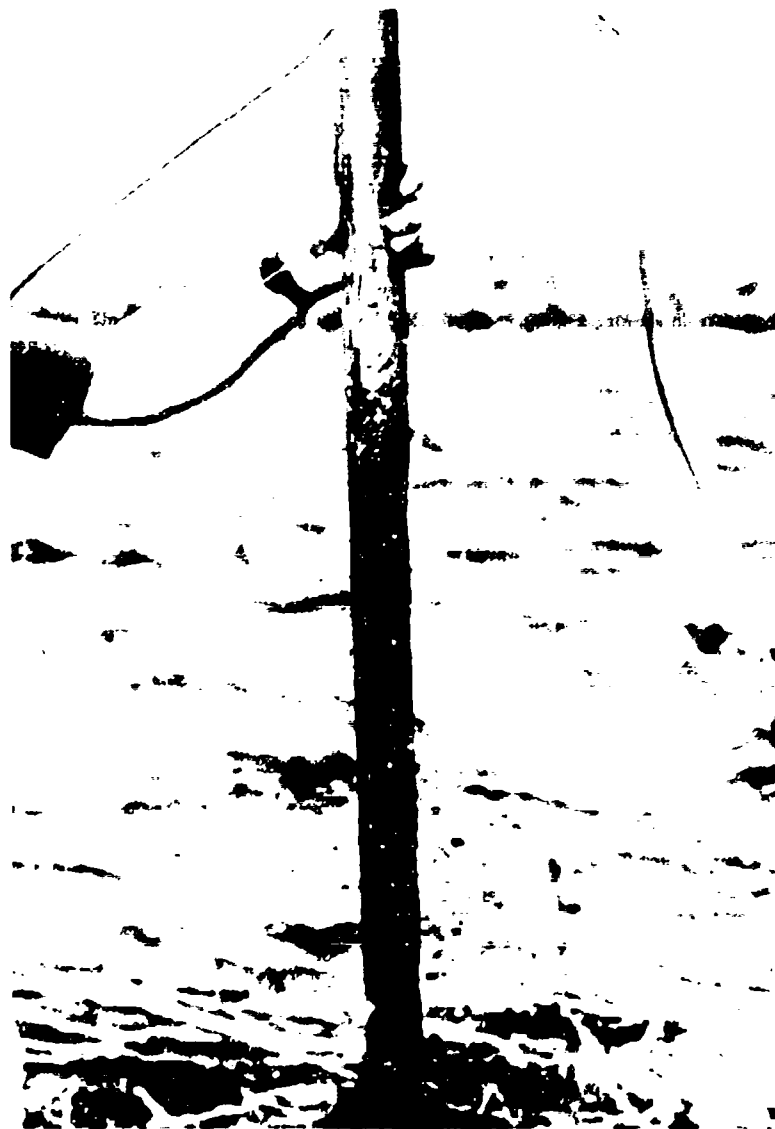
Figure 16. 50.8-mm hollow steel pipe anode in Section 2 failed in 5 days at a voltage gradient of 0.008 V/mm

73. Steel corrosion occurred very rapidly at the Polecat Bay site. The 50.8-mm hollow steel pipe, used initially, failed by corroding to such a degree that the electrical circuit was broken in about five days. The steel pipe failures are shown in Figures 16 and

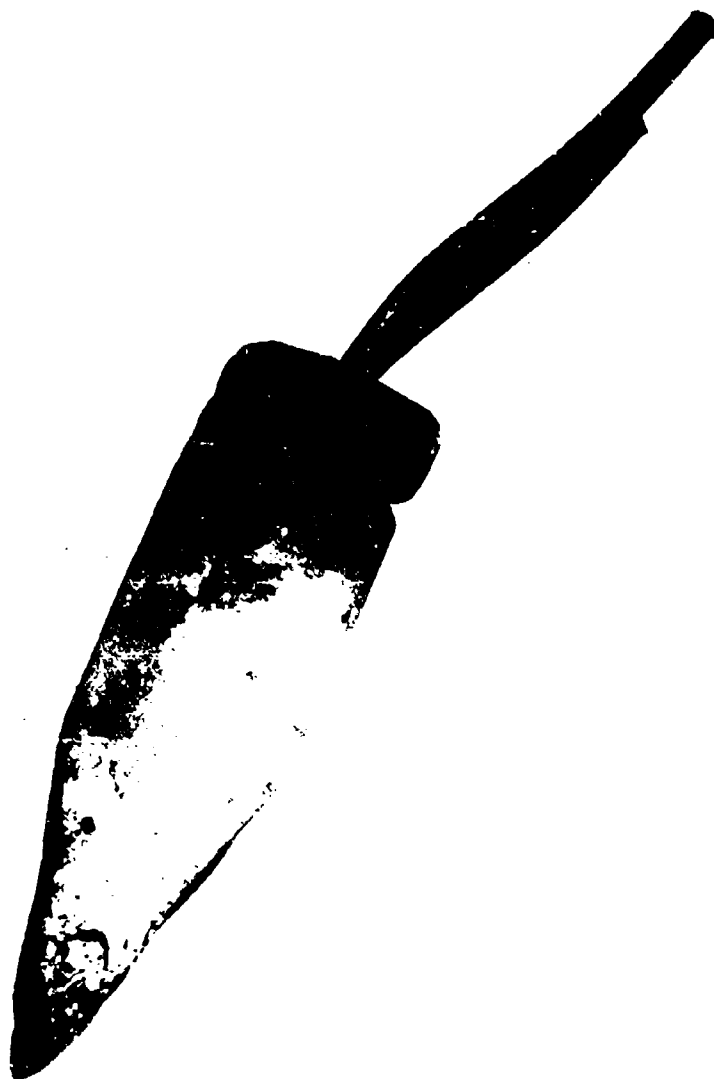
Figure 21. 10.9-kg Duriron electrode anode in Section 4 failed in 53 days at a voltage gradient of 0.008 V/mm
